# IN-PLACE CAPSTONE REPAIR AVOIDS COSTLY BUILDING DISRUPTION

## BIG restores 760 linear feet without demolition or full-building scaffolding

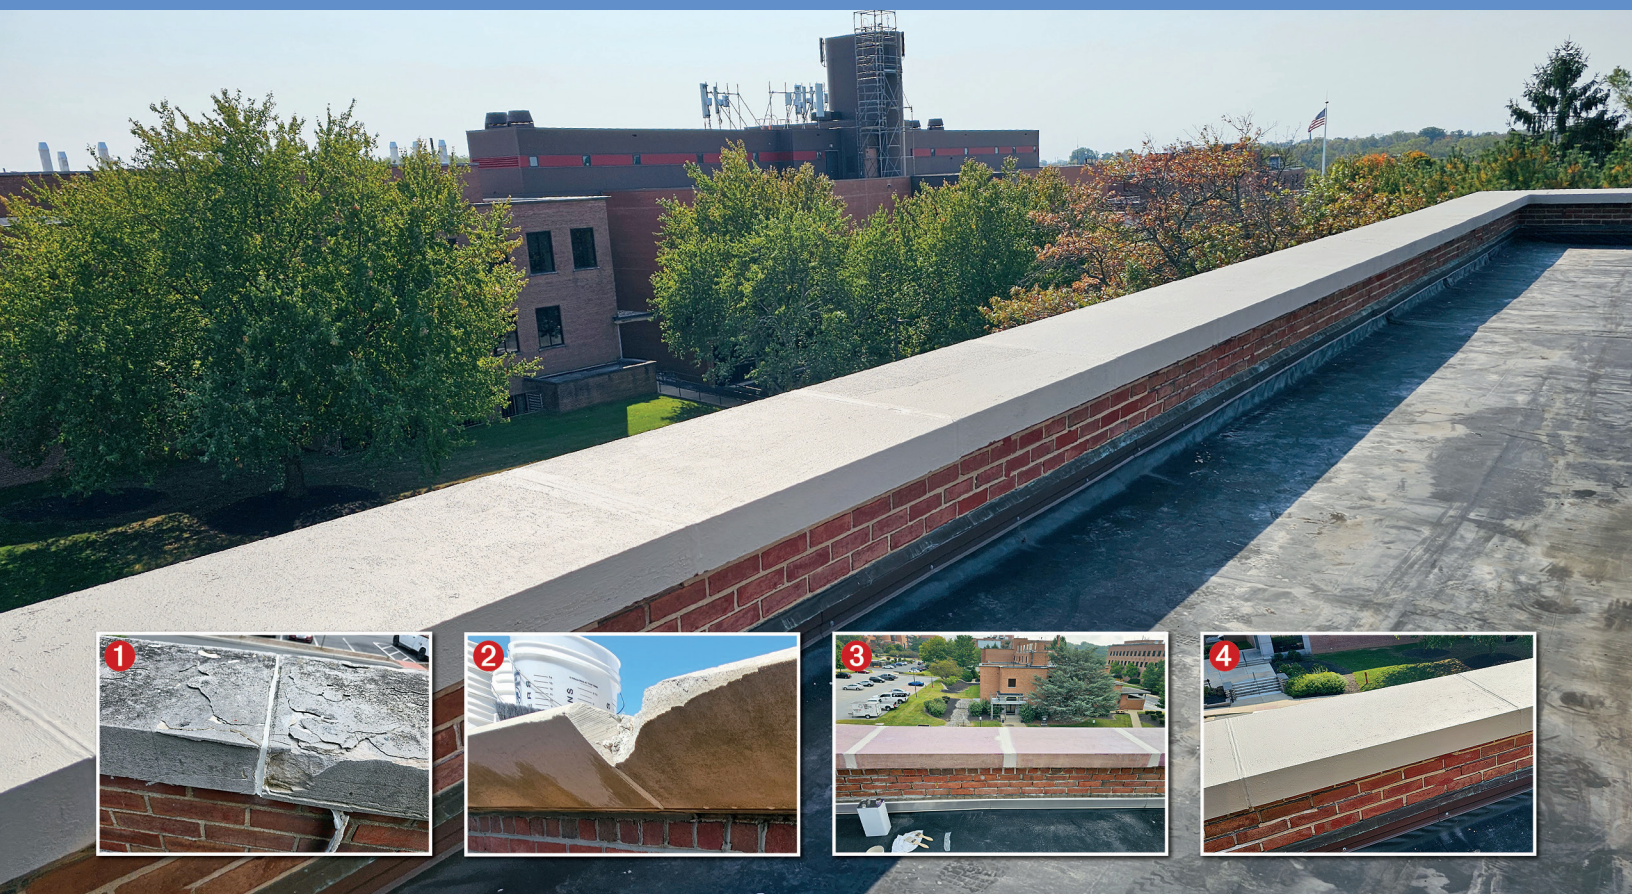
At a Mid-Atlantic research facility, worn capstones and **failed joints allowed water into the parapet**, accelerating deterioration of the concrete and masonry. Conventional replacement would require full-perimeter scaffolding, demolition, disposal and asbestos abatement, increasing cost and disrupting research operations. **BIG repaired the capstone in place** using Belzona rebuilding and reinforced membrane systems, coordinated brick repointing, and worked from the roof and MEWPs. The six-week project stopped water intrusion, preserved the campus's architectural color palette, minimized asbestos disturbance, and **extended parapet service life** while reducing labor, cost, waste and operational disruption.

- 1 Delamination, scaling and failed capstone joint
- 2 Belzona 4141 Magma-Build restores spalled areas
- 3 Reinforced stripe coat bridges capstone joints
- 4 Two Belzona 3111 membrane coats seal capstones

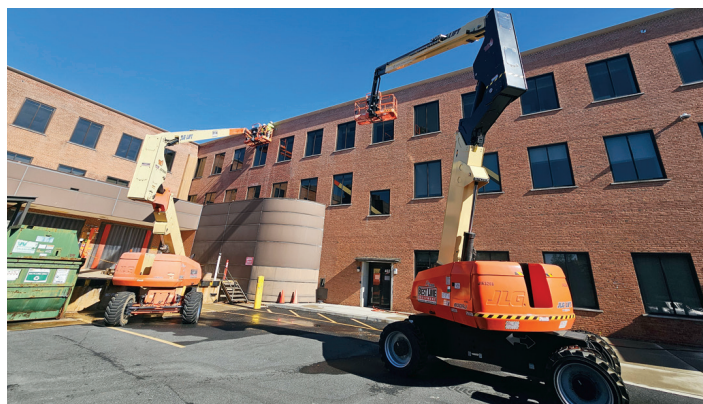
MEWP access avoided full-building scaffolding and disruption.
