# CORRODED CLARIFIER FEED WELL REPAIRED WITHOUT COSTLY REPLACEMENT

## Composite Repair Restored Treatment Capacity While Extending Service Life

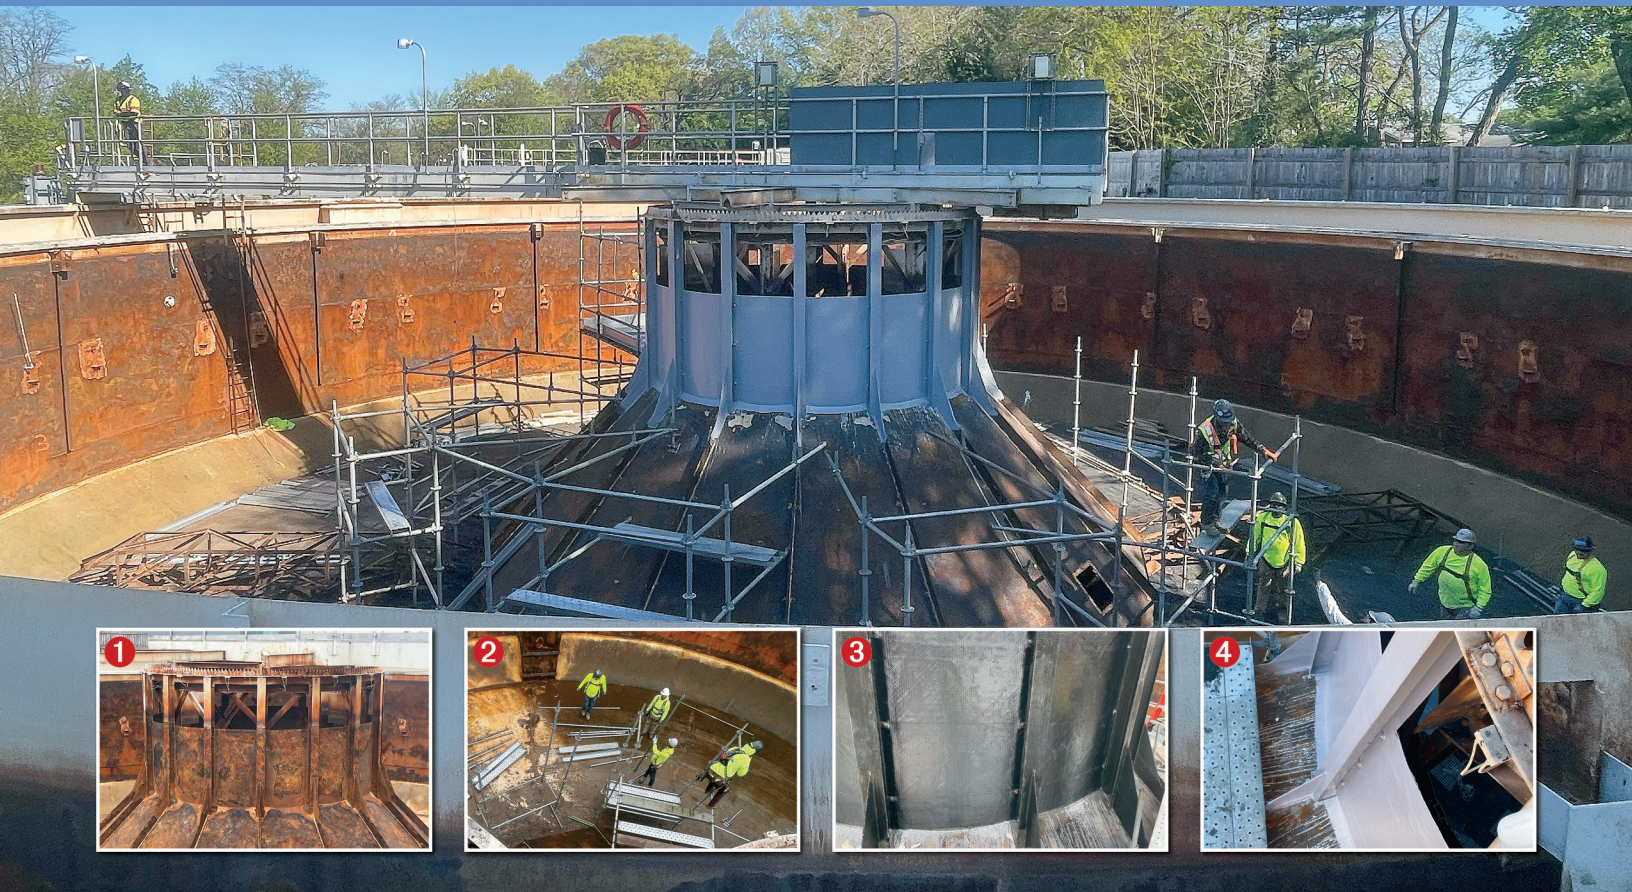
- ① Extensive metal loss, wall thinning, and pinholing
- ② Scaffold for safe access assembled within clarifier
- ③ Superwrap II conforms to complex geometries
- ④ NSF-approved Belzona 5812 DW protective coating

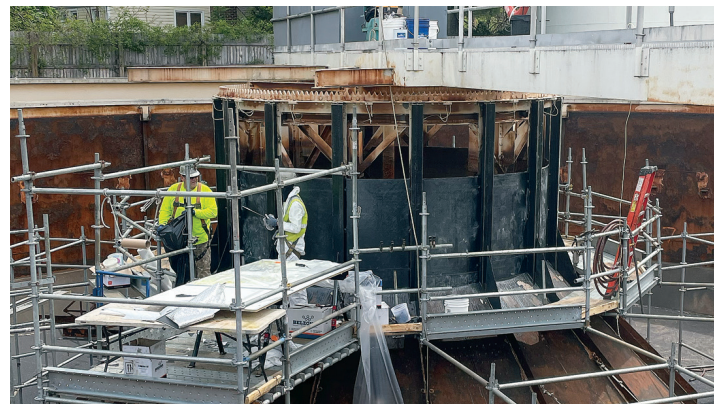
*BIG technicians apply SuperWrap II to restore structural integrity.*

During a planned maintenance outage at a **30-million-gallon-per-day (MGD)** New Jersey water treatment plant, severe corrosion and structural deterioration **forced a carbon-steel clarifier feed well out of service**, reducing treatment capacity. Replacing the structure would have increased costs and *extended* downtime. Banks Industrial Group (BIG) restored the clarifier feed well in place by overcoming limited access, rebuilding damaged steel with Belzona repair composites, reinforcing the structure with **Belzona SuperWrap II**, and protecting it with NSF-approved Belzona 5812 DW coating. The repair returned the clarifier to service, restored treatment capacity, **extended asset life**, and **avoided welding, hot work, and costly replacement**.
