BELZONA REPAIR SOLVES CHILLER COMPRESSOR ELBOW CORROSION ISSUES

Fast, In-Place Superwrap II Application Fixes Corrosion Under Insulation Damage

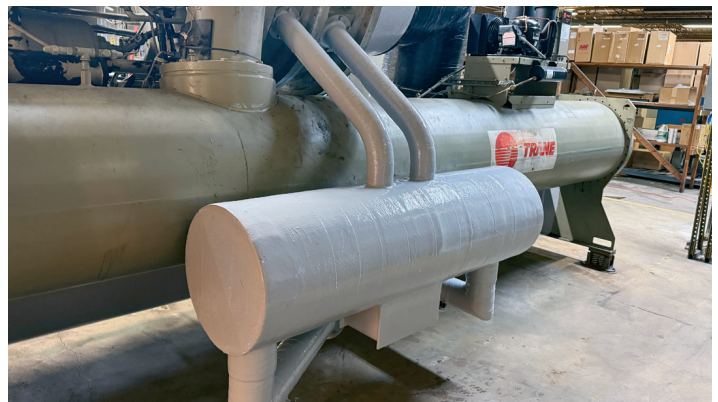
Corroded economizer restored and protected by Superwrap II.
